# Weathering Test (Metal Weather)

## Thí nghiệm khả năng kháng ăn mòn kim loại

Khả năng chống ăn mòn dài hạn mà không bị ảnh hưởng bởi tia UV và mưa

**Long time anti-corrosion property  
without any influence by UV and Rain.**

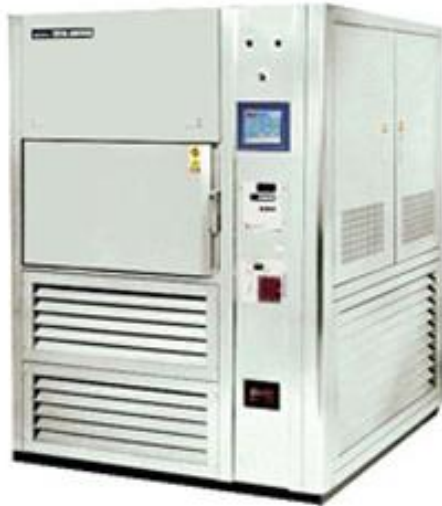
- Sơn lót  
① XG-PN(Primer)  
Băng cuộn  
② XG(TAPE)  
Sơn phủ  
③ XG(Topcoat)

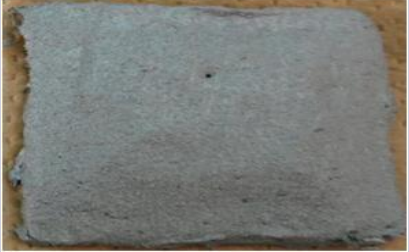
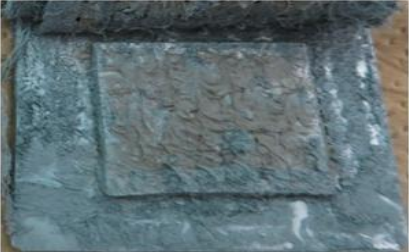
Appearance	Remove Tape	Remove Compound	Result
Initial Bắt đầu

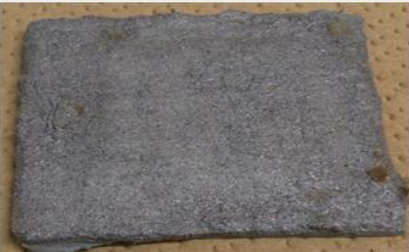
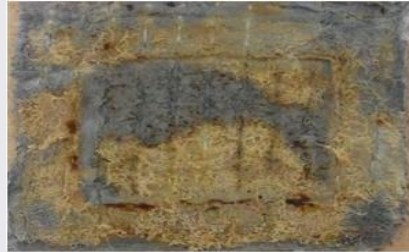
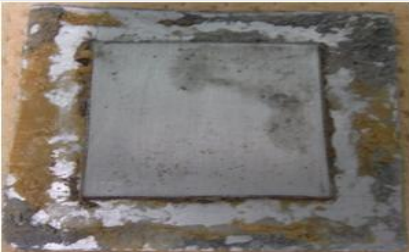
No Rust Không gỉ sét
*10 Year 10 năm

\* 1 năm tương đương với 10 chu kỳ bức xạ = 8 giờ.

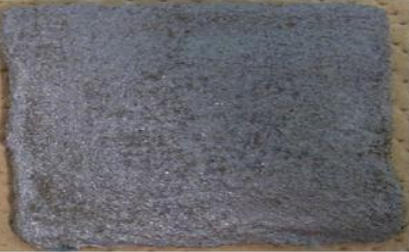
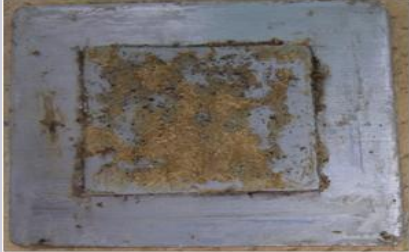
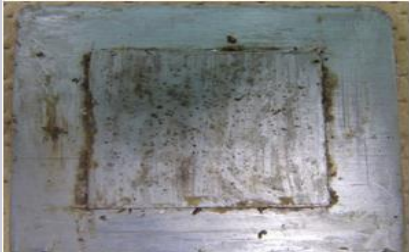
No Rust Không gỉ sét
*20 Year 20 năm

Small Pitting Bắt đầu xuất hiện lỗ ăn mòn nhỏ
