EWFA CERTIFICATE OF TEST	CERTIFICATE No.: SFC 43878800c.1 Page 1 of 1
---------------------------------	---

Fire resistance test in accordance with EN 1366-4:2006 of three control joints in a Hebel block wall (AAC) protected with Alseal AS-1001 Fire Retardant Sealant.

38838800d.1

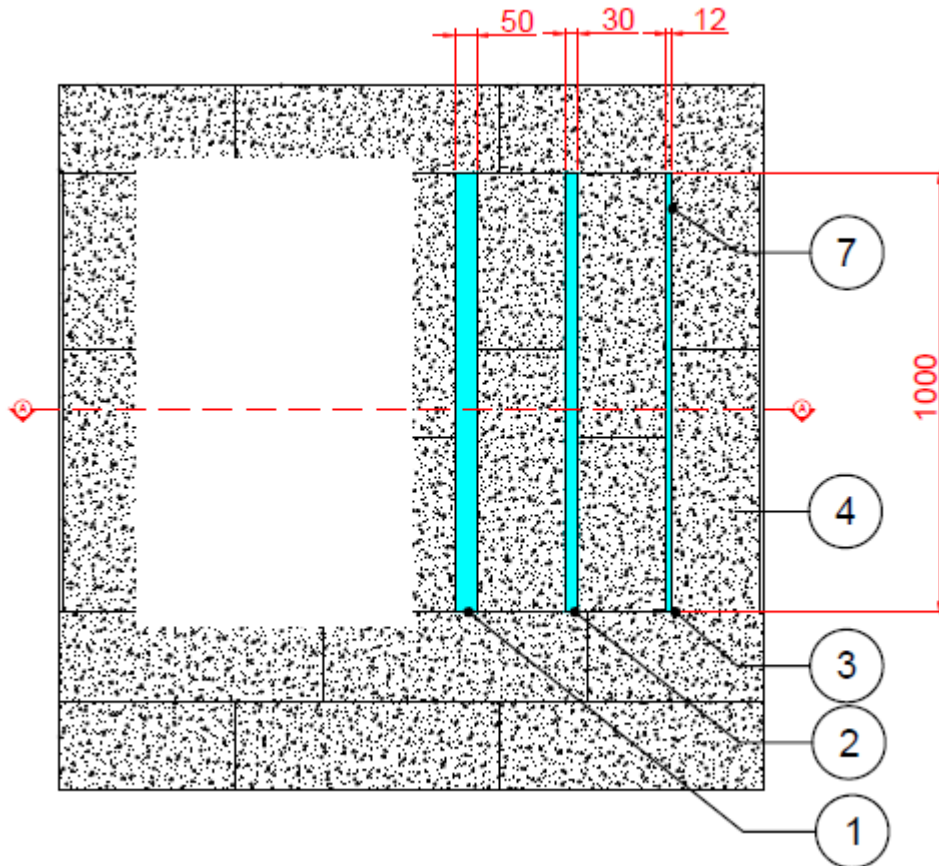
Figure A1.1: Elevation of Test Specimen, Unexposed side

The full description of the specimen is provided in Figures A1.1 to A1.2 and the 'Schedule of Components' in Section 2.

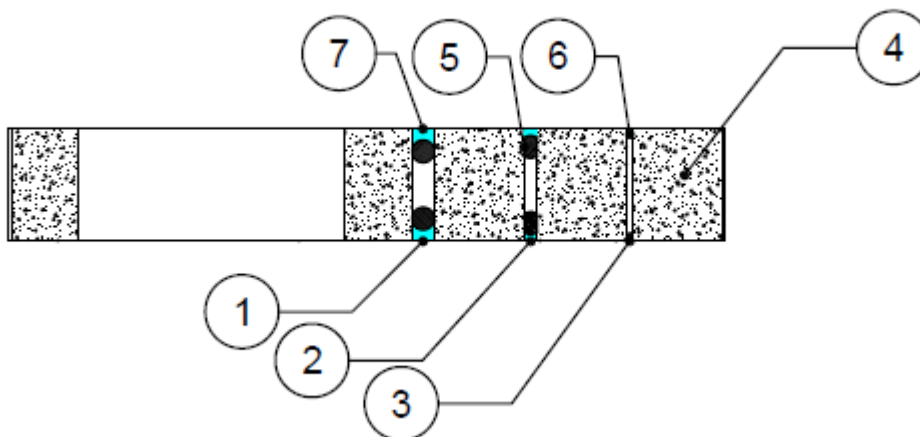
Figure A1.2: Horizontal Cross-Section A-A

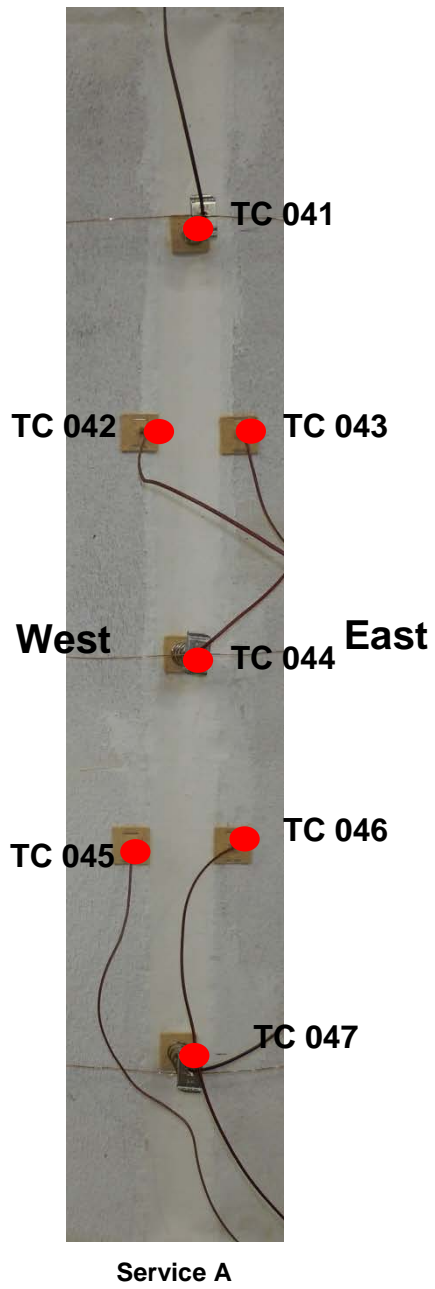
Figure A4.1: Unexposed surface thermocouple locations

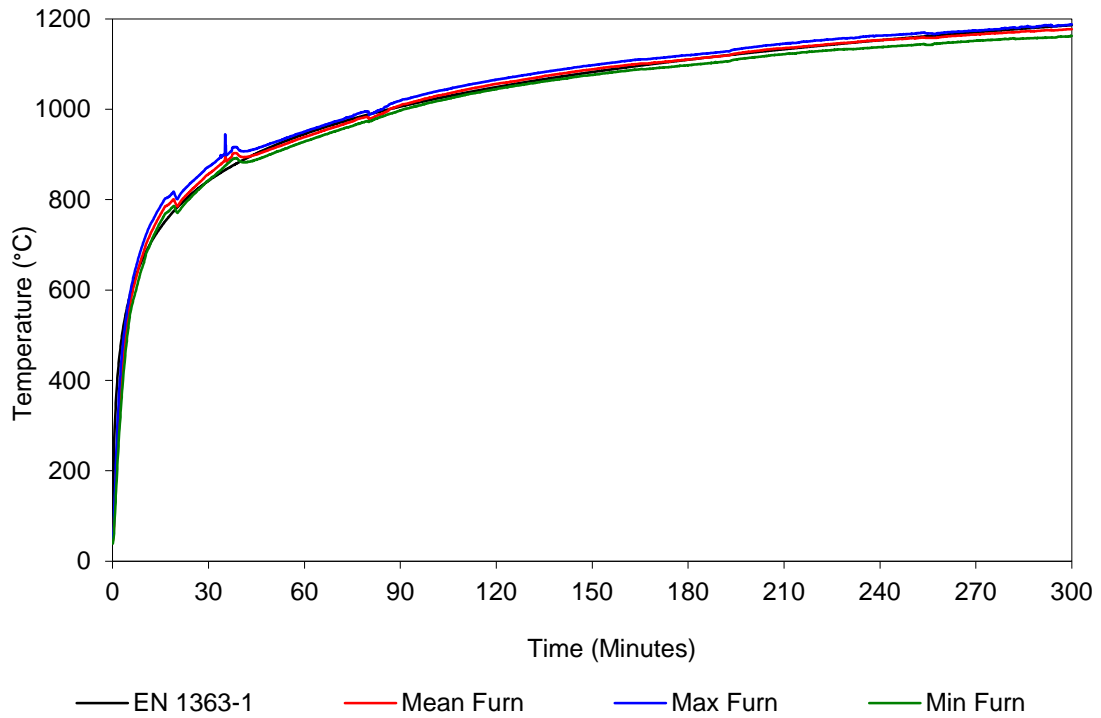
Figure A5.1: Furnace Temperatures vs. Time

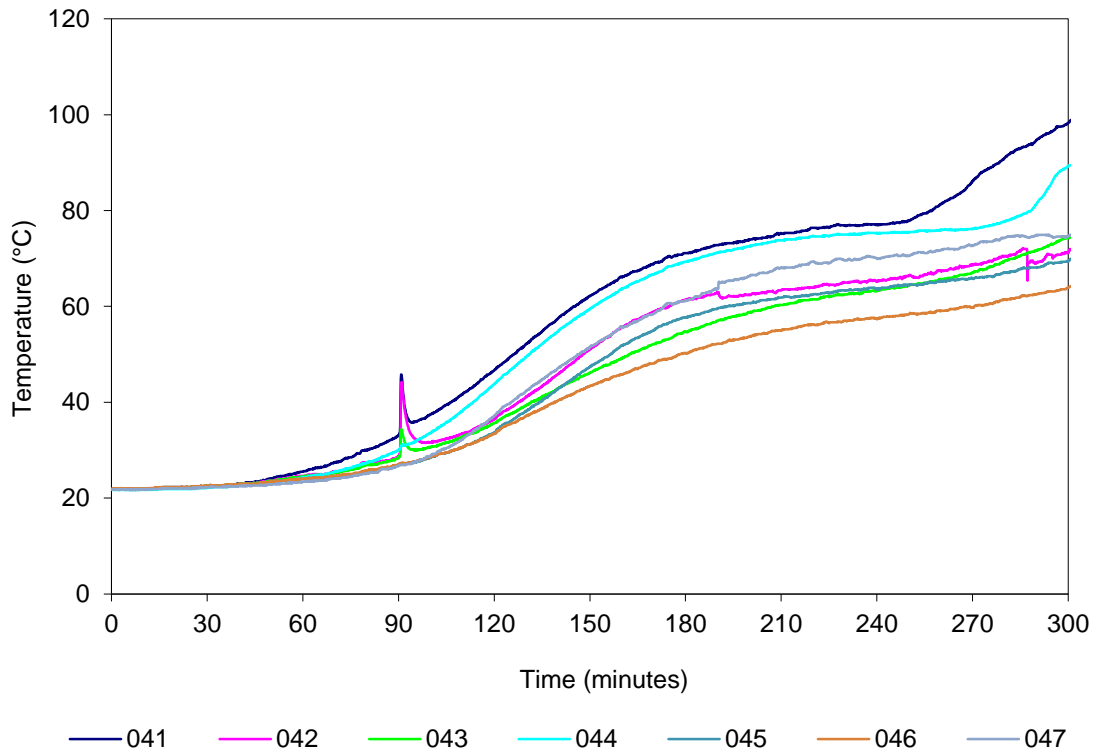
Figure A5.2: Service A. Temperatures vs. time

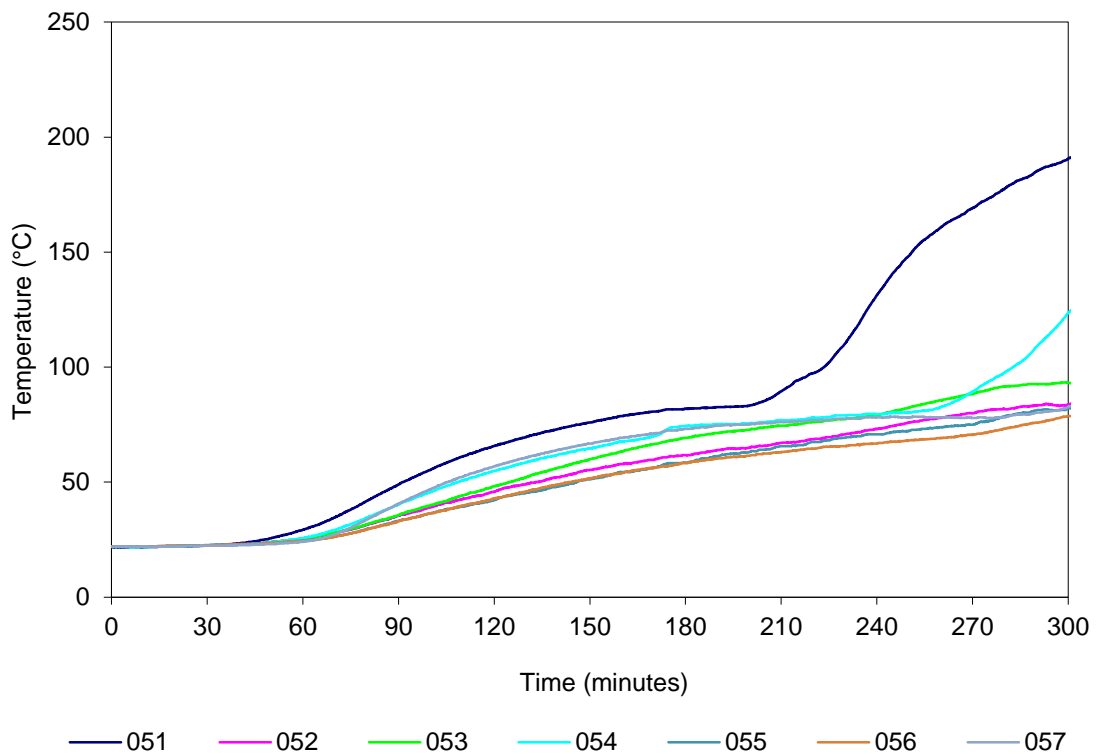
Figure A5.3: Service B. Temperatures vs. time

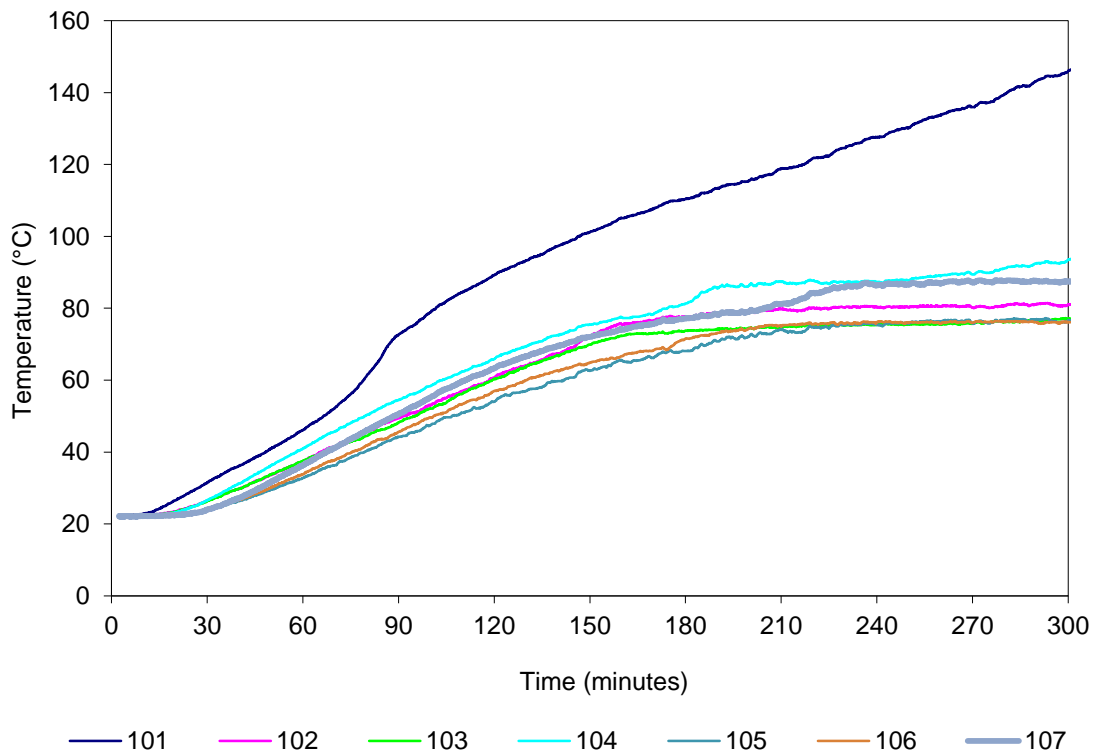
Figure A5.4: Service C. Temperatures vs. time

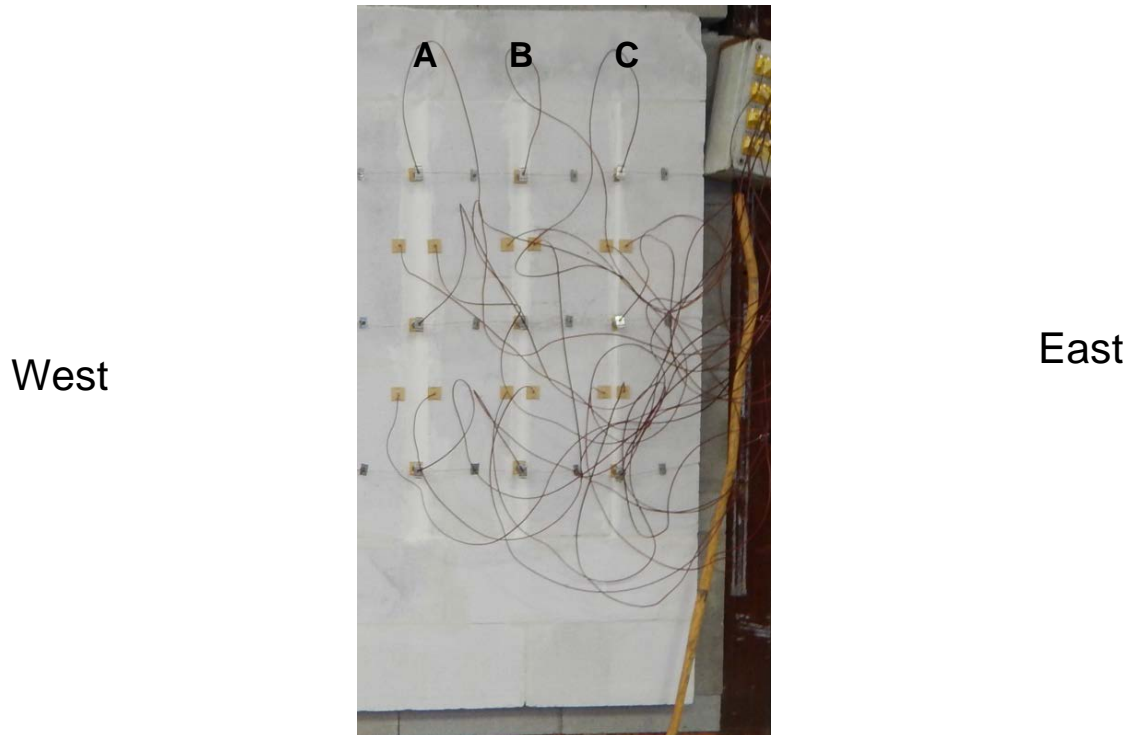
Figure A6.1: Unexposed face of specimen before commencement of the fire-resistance test

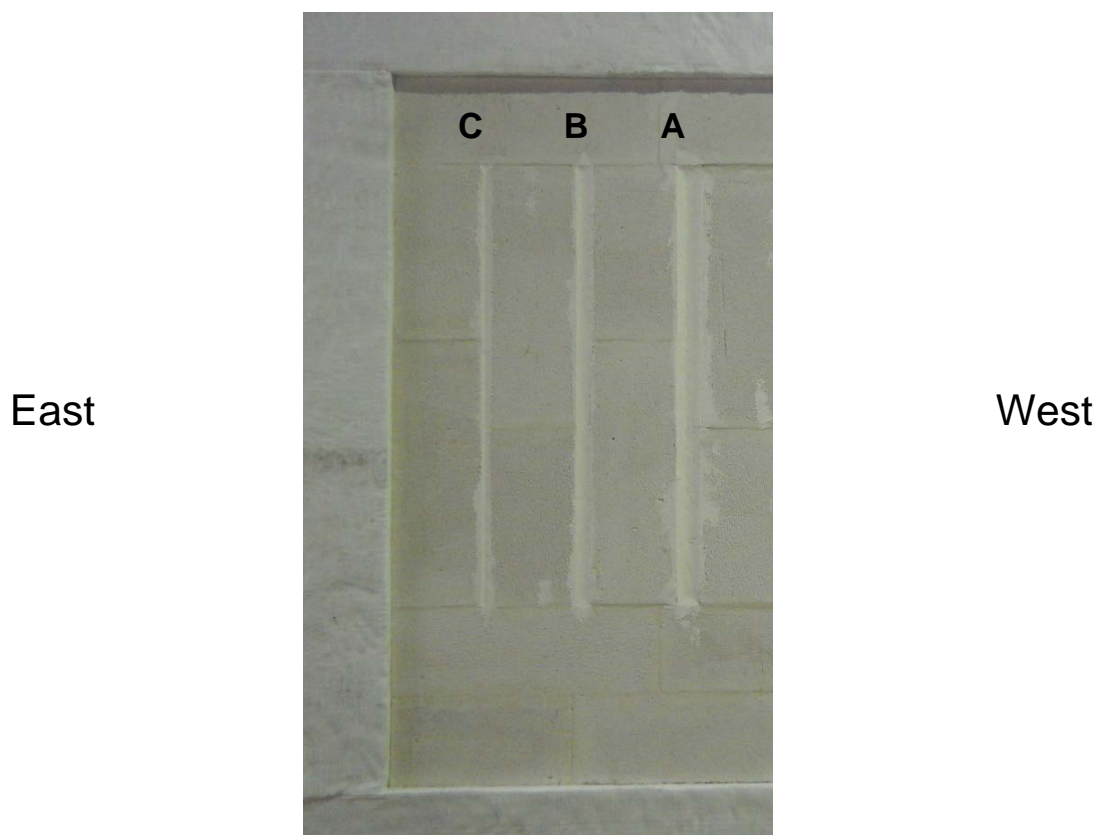
Figure A6.2: Exposed face of specimen before commencement of the fire-resistance test

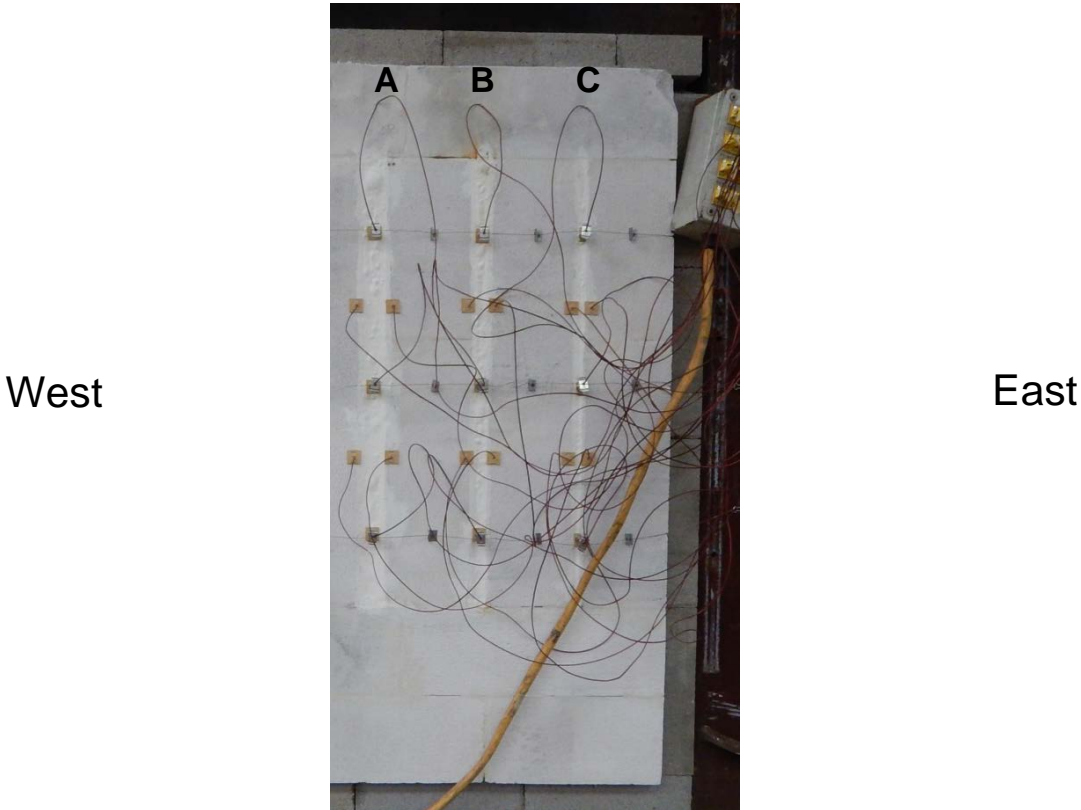
Figure A6.3: Unexposed face of specimen at the end of the test.

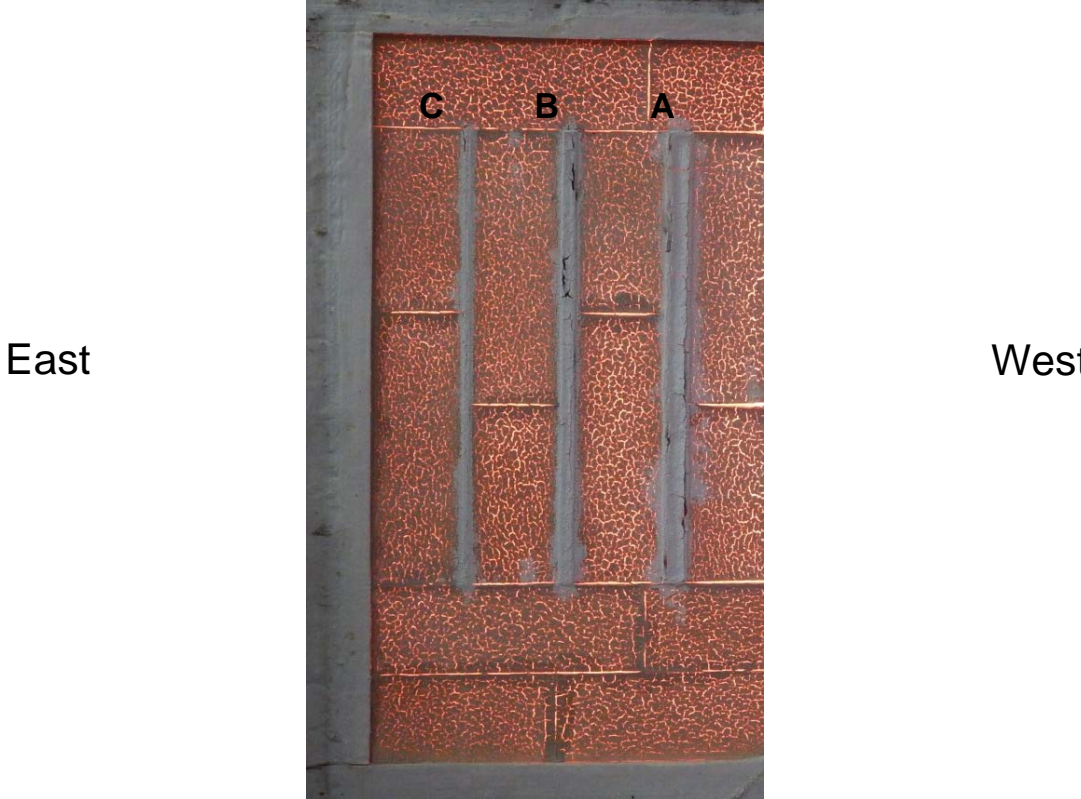
Figure A6.4: Exposed face of specimen at the end of the test.

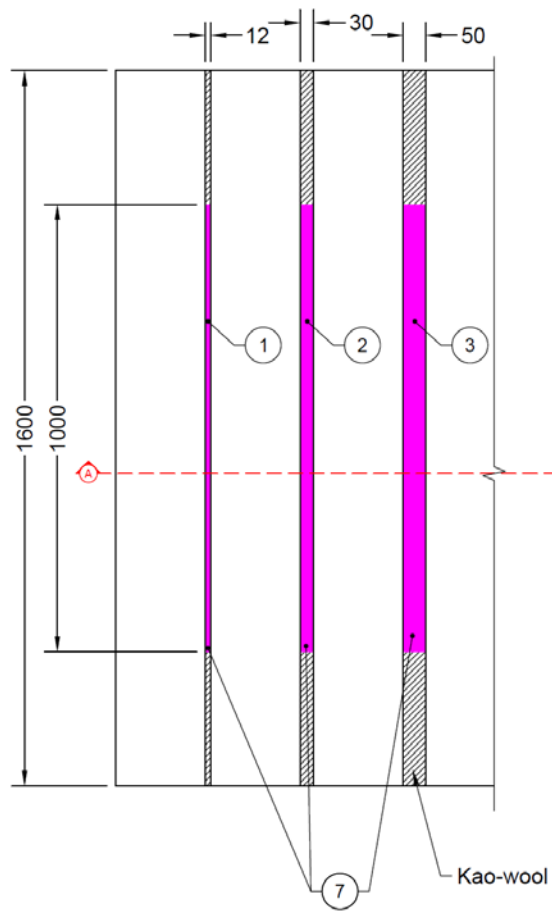
Figure A1.1: Elevation of Test Specimen, Unexposed side

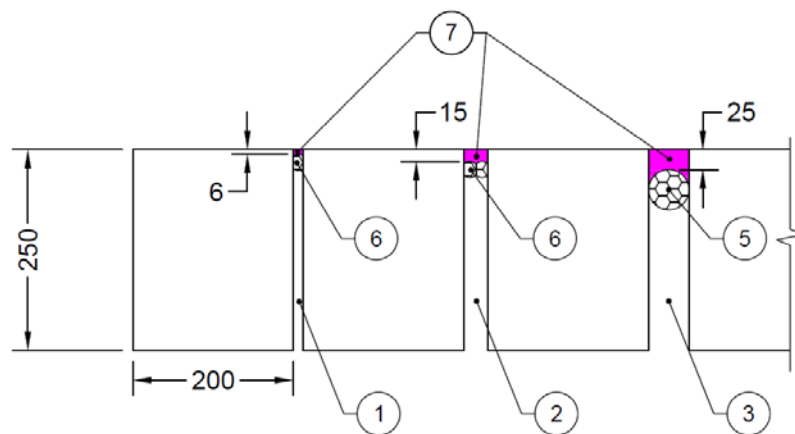
Figure A1.2: Horizontal Cross-Section A-A

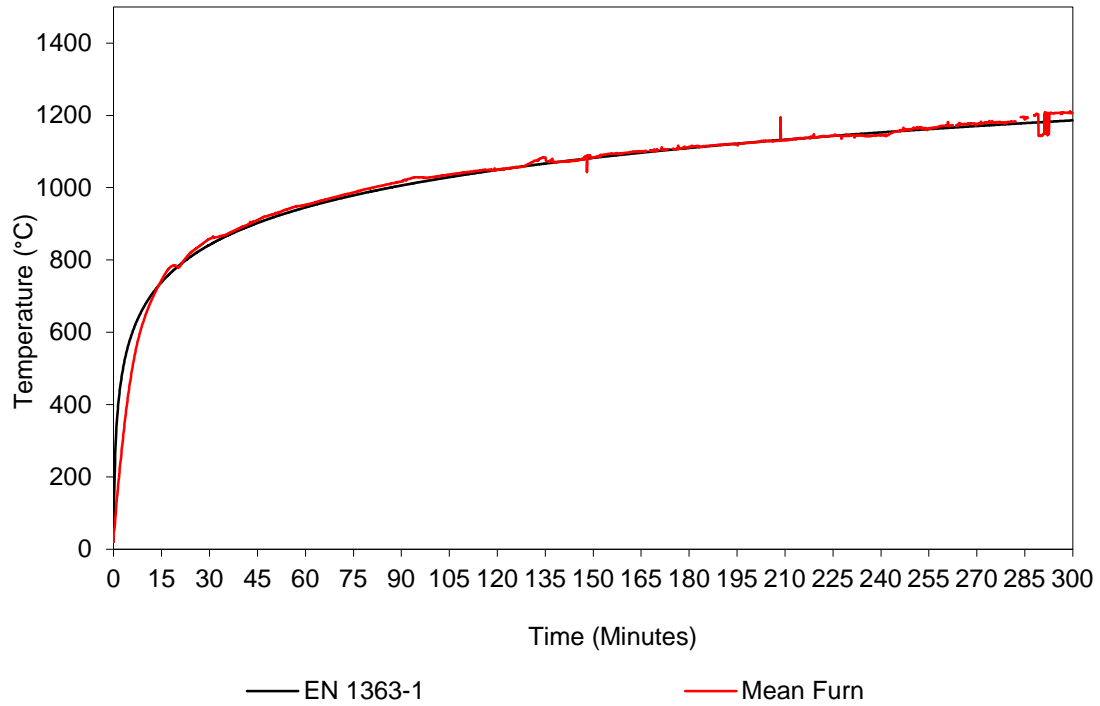
Figure A5.1: Furnace Temperatures vs. Time

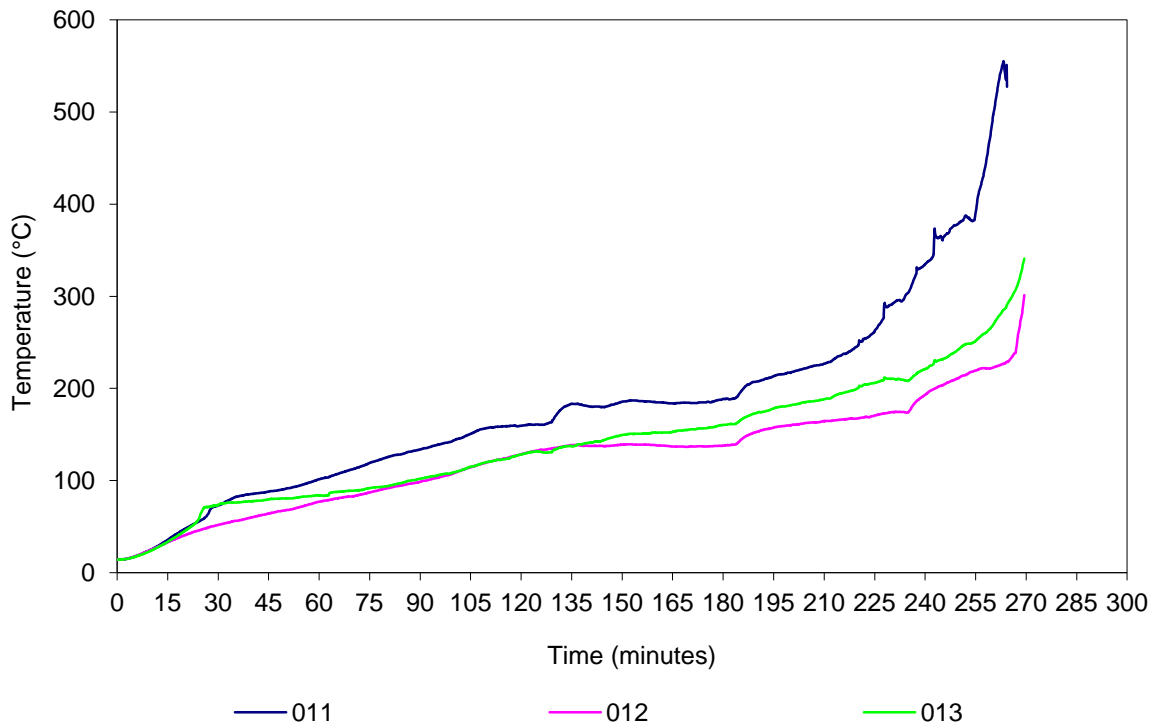
Figure A5.2: Service A on the Hebel (west side of the control joint). Temperatures vs. time

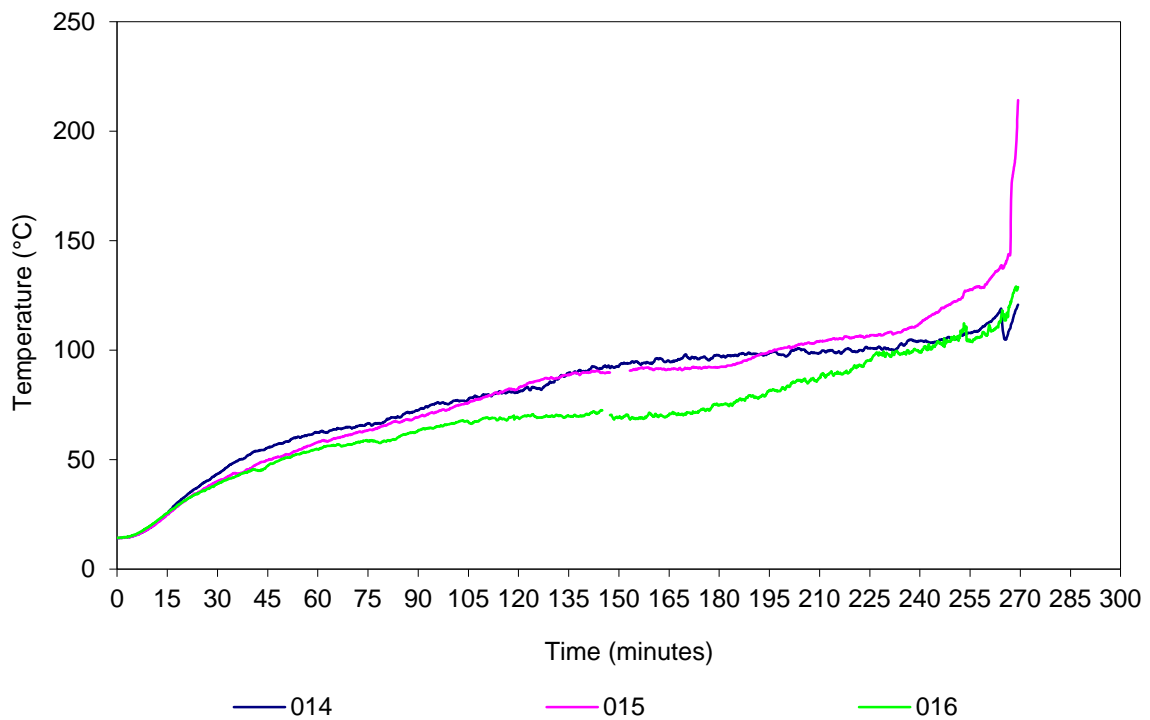
Figure A5.3: Service A on the sealant (mid-wide of the control joint). Temperatures vs. time

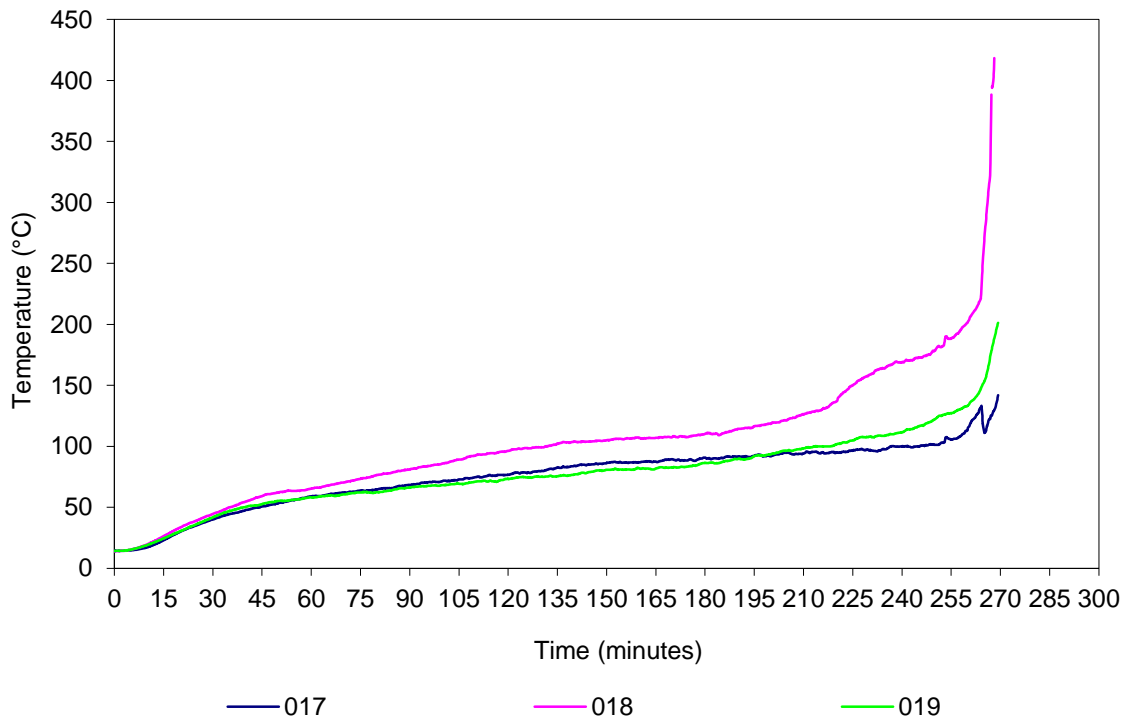
Figure A5.4: Service A on the Hebel (east side of the control joint). Temperatures vs. time

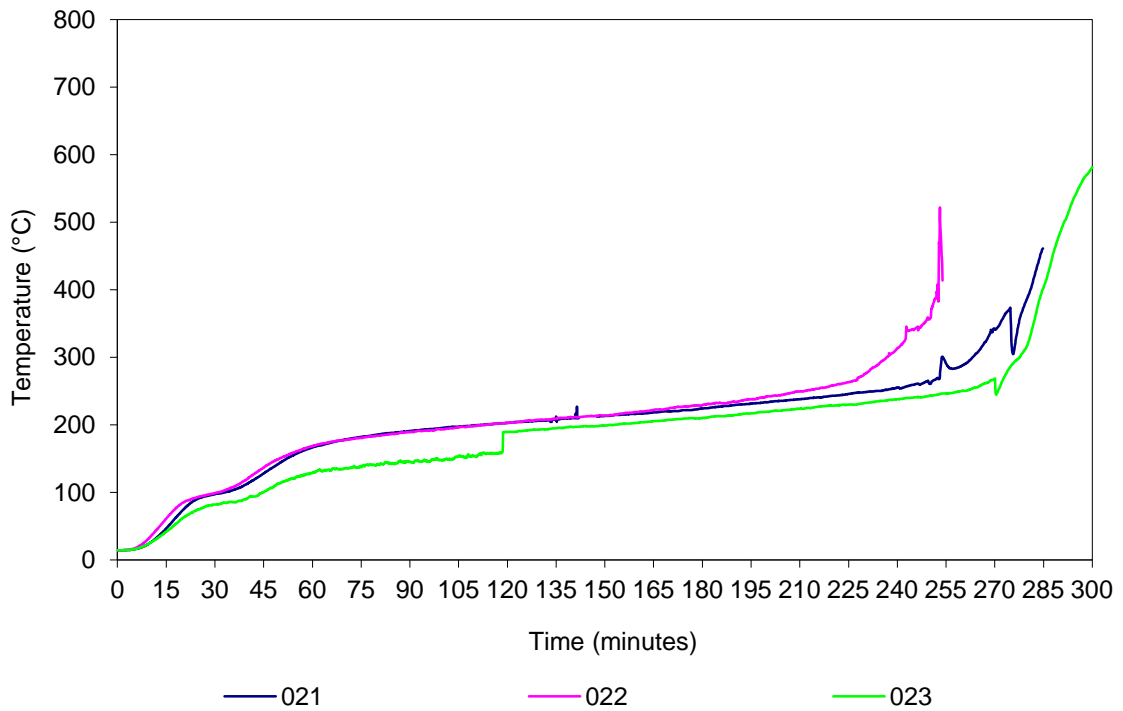
Figure A5.5: Service B on the Hebel (west side of the control joint). Temperatures vs. time

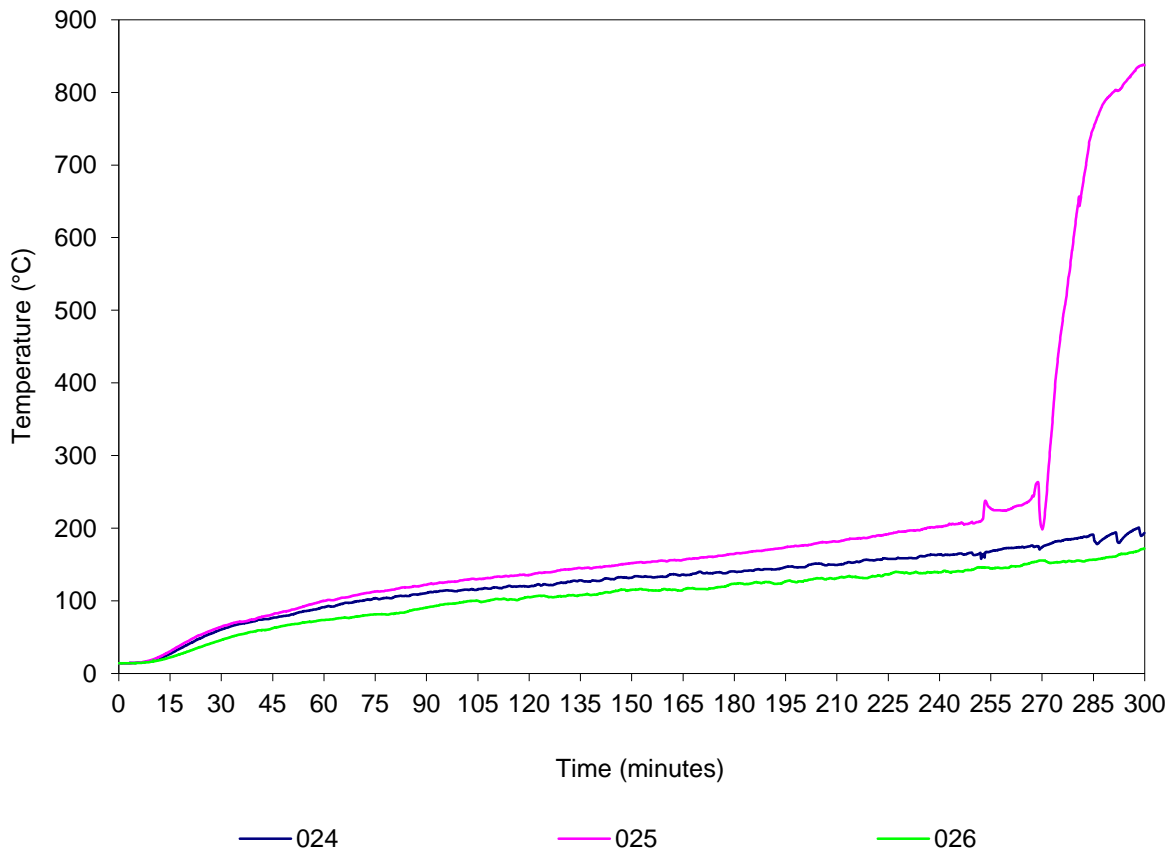
Figure A5.6: Service B on the sealant (mid-wide of the control joint). Temperatures vs. time

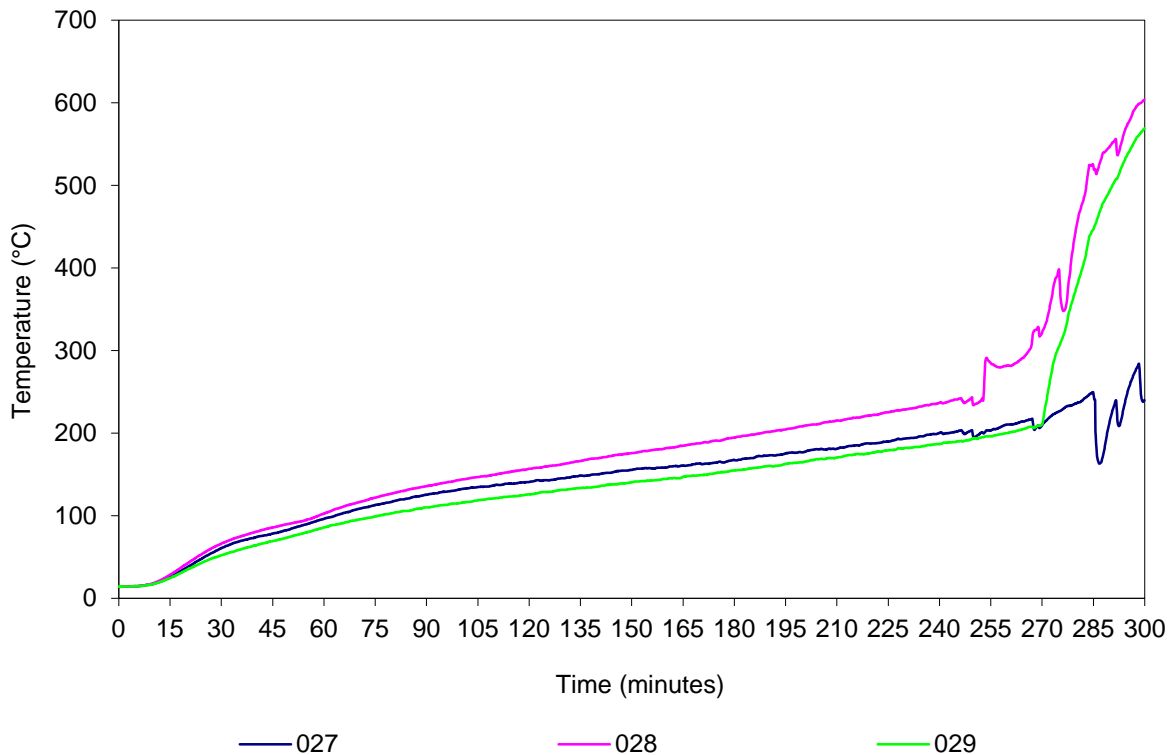
Figure A5.7: Service B on the Hebel (east side of the control joint). Temperatures vs. time

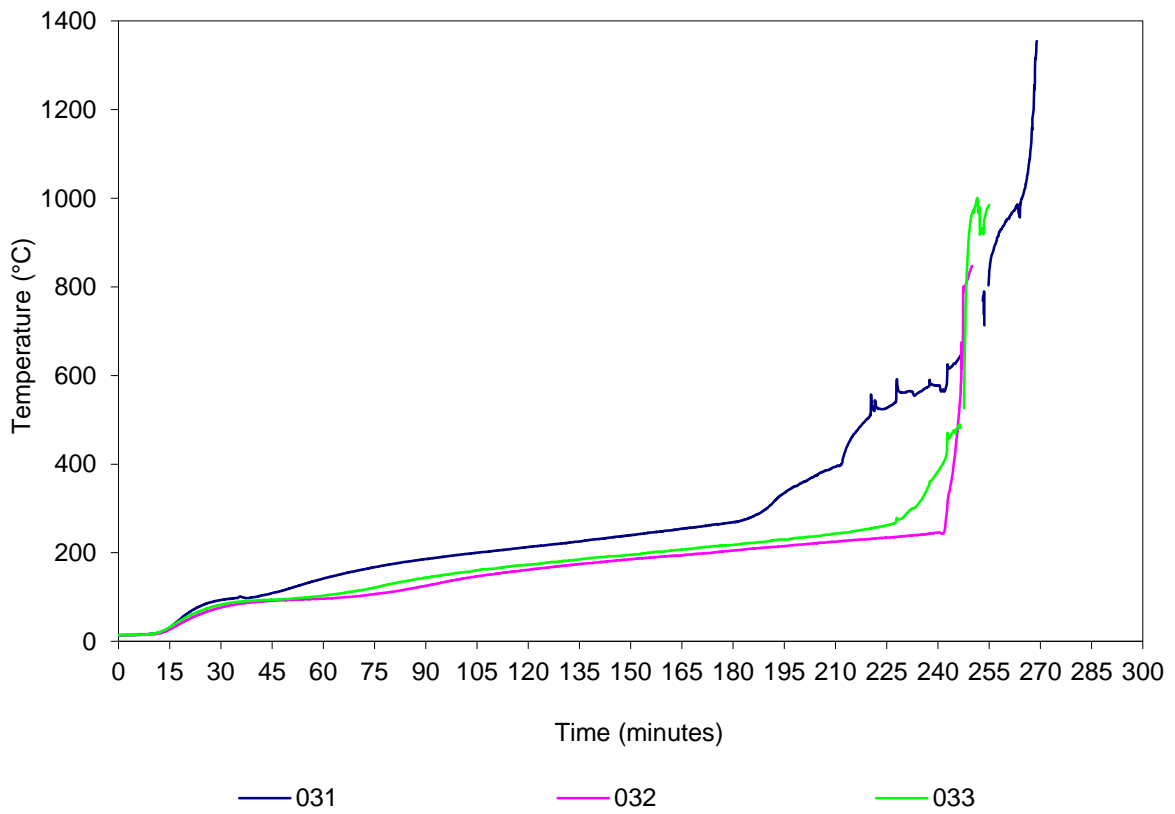
Figure A5.8: Service C on the Hebel (west side of the control joint). Temperatures vs. time

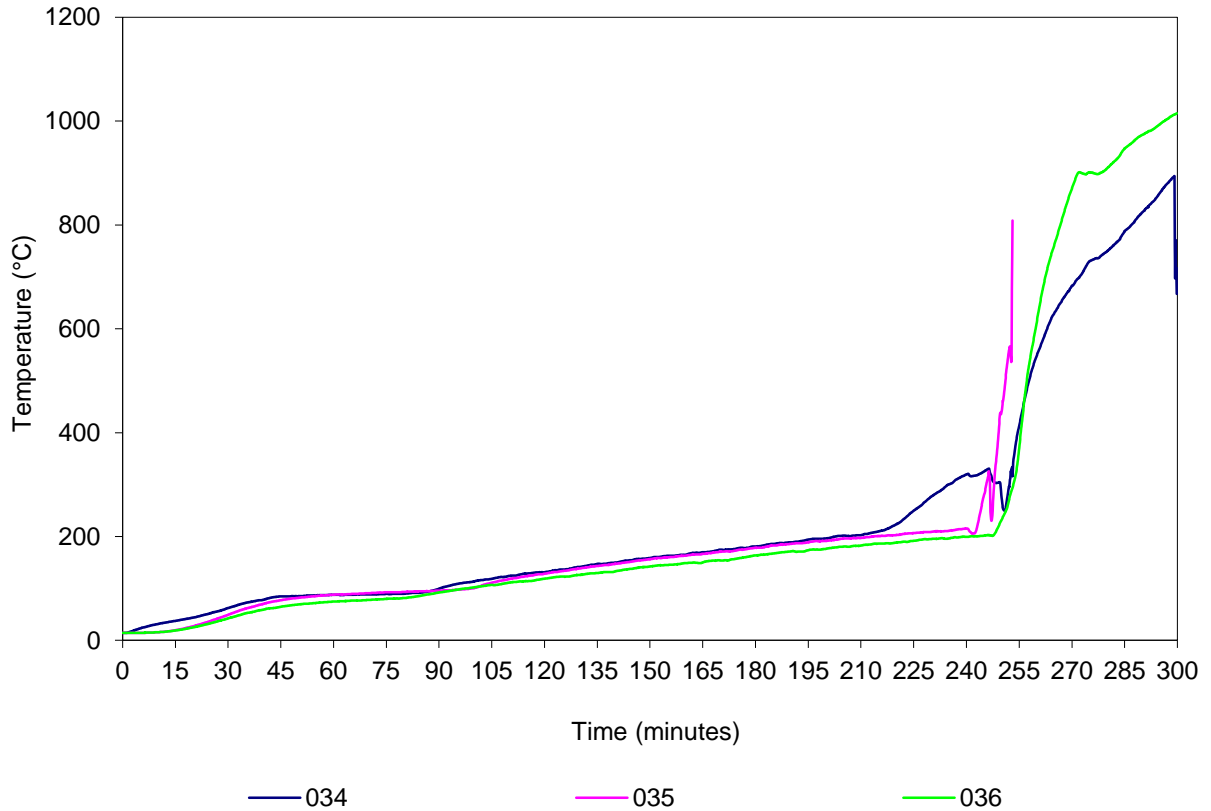
Figure A5.9: Service C on the sealant (mid-wide of the control joint). Temperatures vs. time

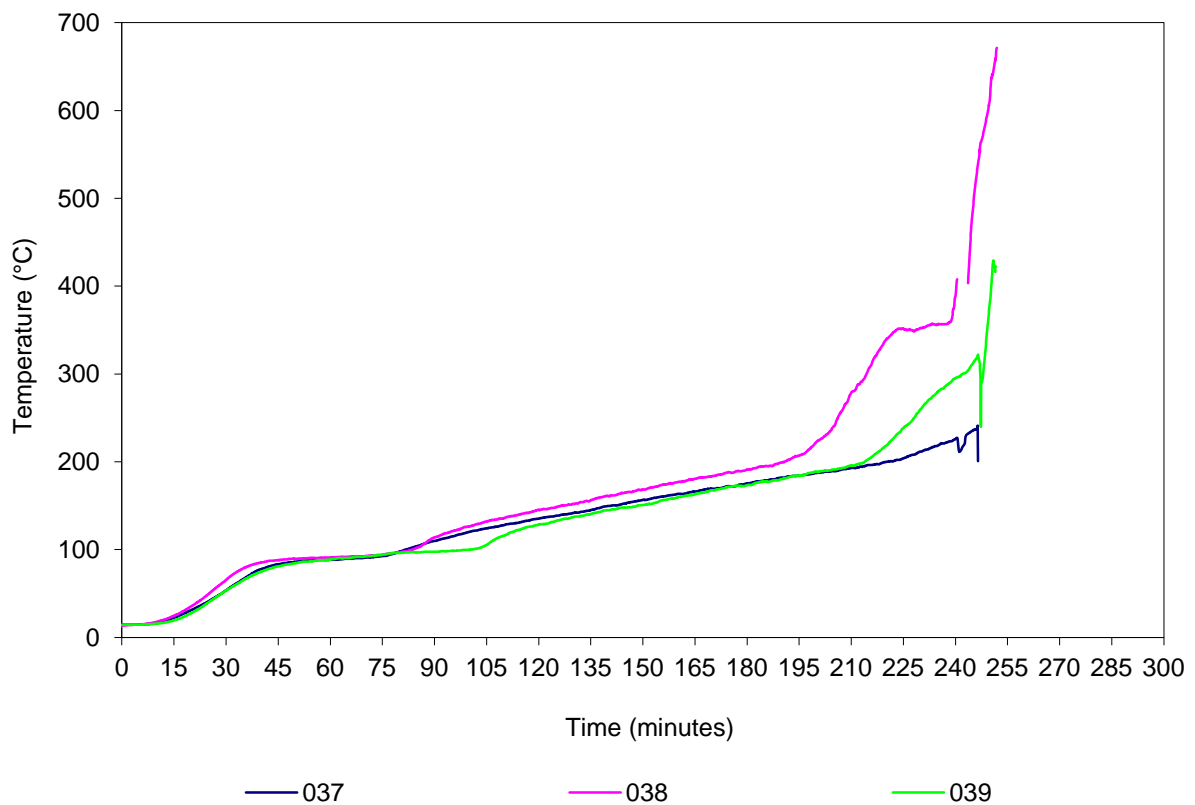
Figure A5.10: Service C on the Hebel (east side of the control joint). Temperatures vs. time

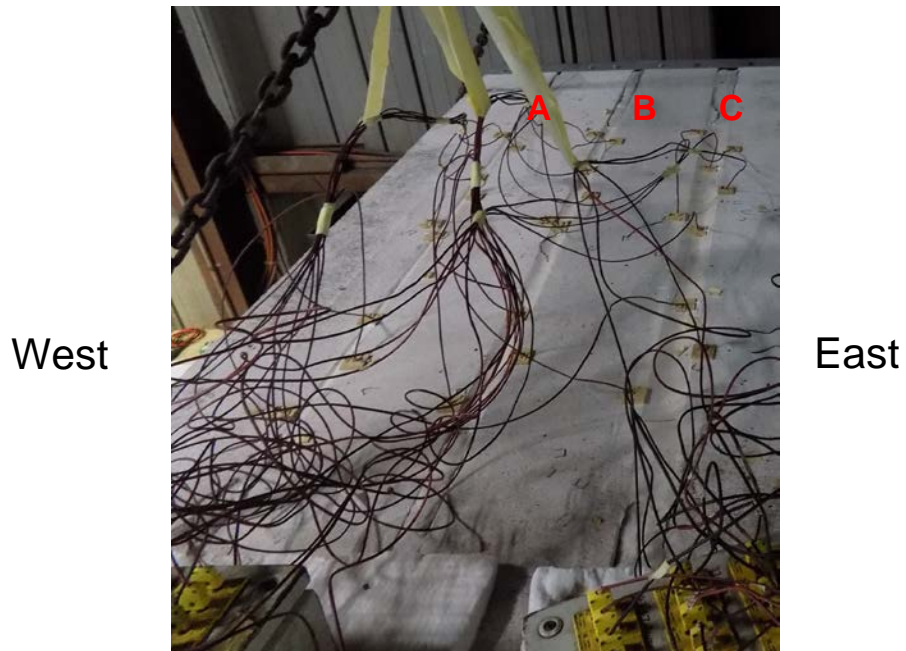
Figure A6.1: Unexposed face of specimen before commencement of the fire-resistance test

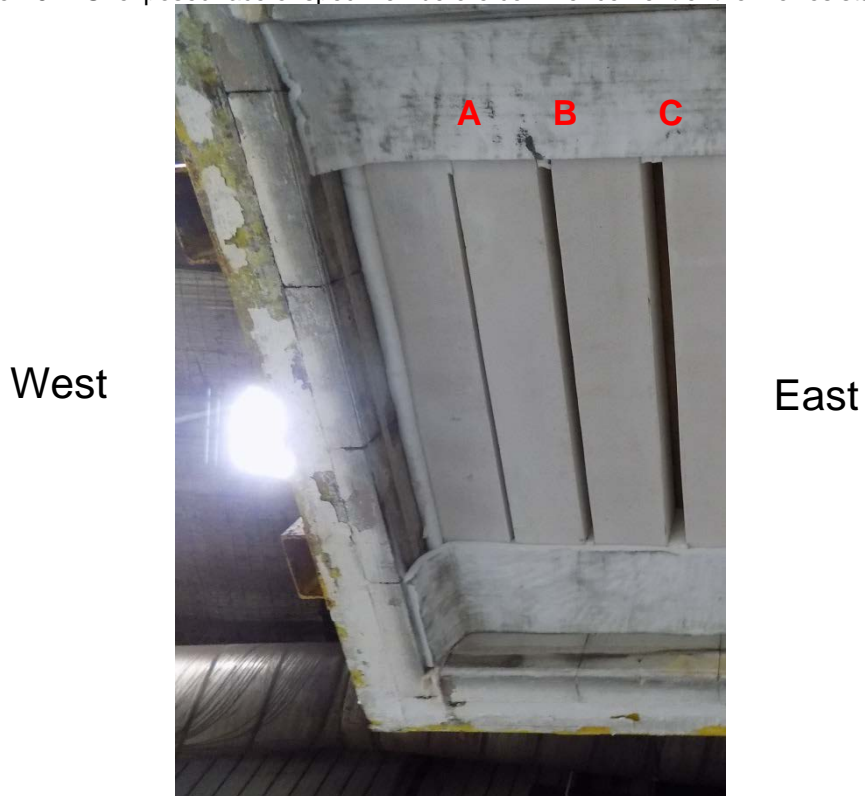
Figure A6.2: Exposed face of specimen before commencement of the fire-resistance test

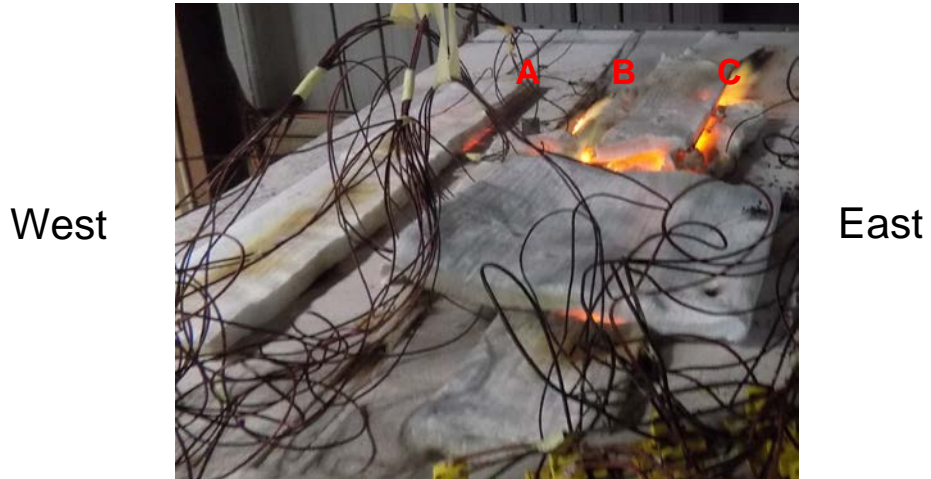
Figure A6.3: Unexposed face of specimen at the end of the test.

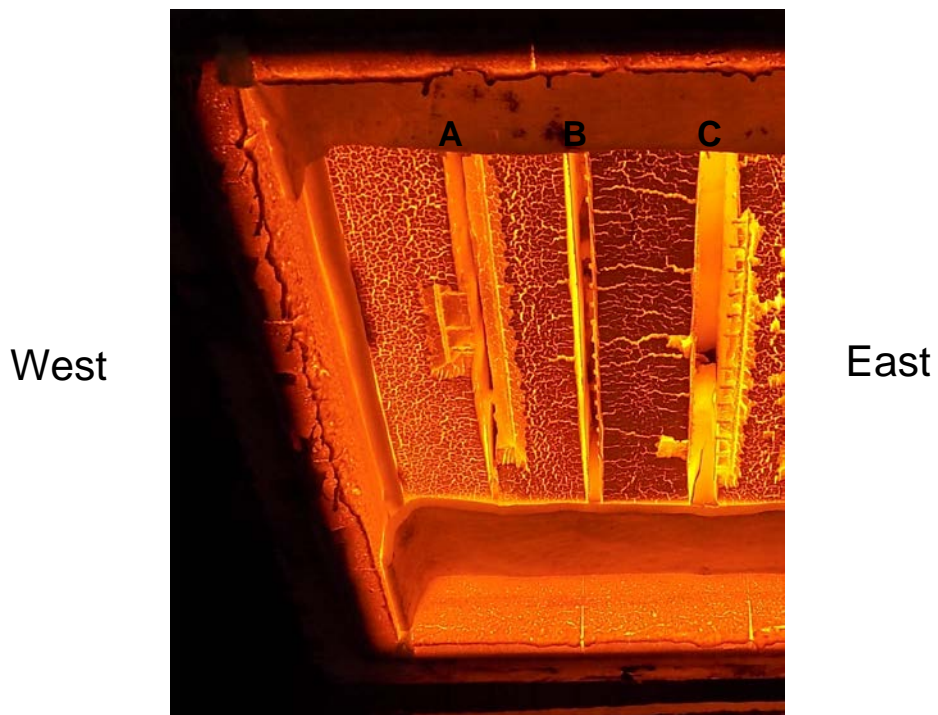
Figure A6.4: Exposed face of specimen at the end of the test.
